**INVESTIGATION OF THE SONIC FATIGUE
CHARACTERISTICS OF RANDOMLY EXCITED
ALUMINUM VISCOELASTIC PANELS
AT AMBIENT TEMPERATURES**

by B. J. Moskal

Prepared under Contract No. NAS 1-4728 by
NORTH AMERICAN AVIATION, INC.
Columbus, Ohio
for Langley Research Center

NATIONAL AERONAUTICS AND SPACE ADMINISTRATION • WASHINGTON, D. C. • APRIL 1966

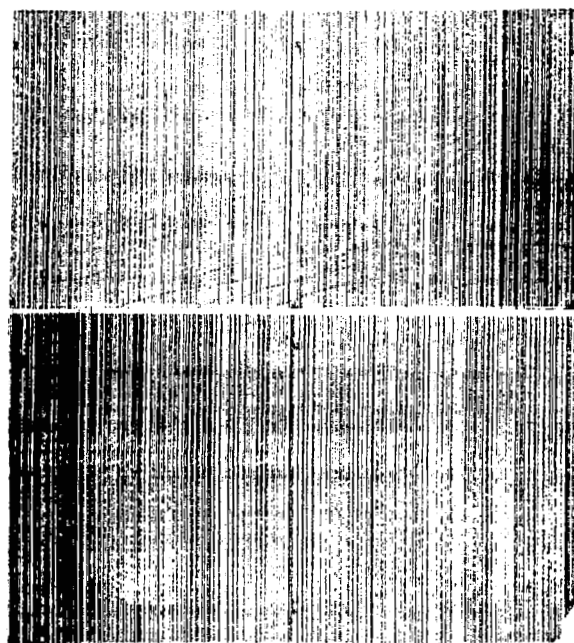
FIG. 7a: SONOFAX RECORDS OF VISCOELASTIC SHEETS

TABLE III: SUMMARY OF VISCOELASTIC PANEL BOND CONDITION
AS OBSERVED FROM SONOFAX RECORDS

GOOD BOND

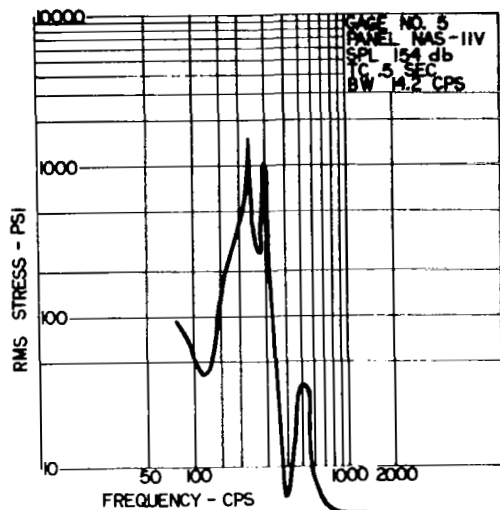
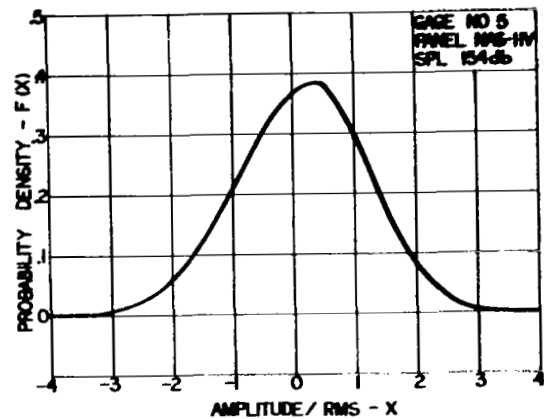
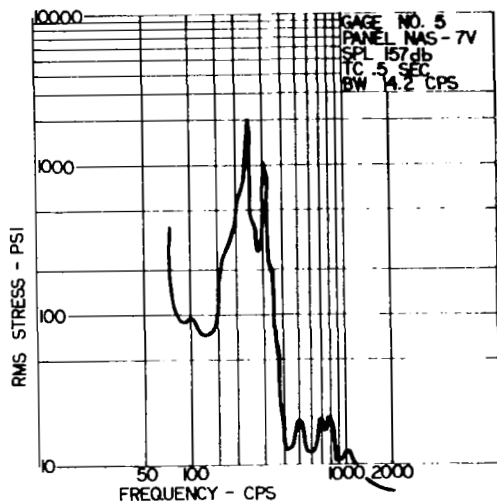
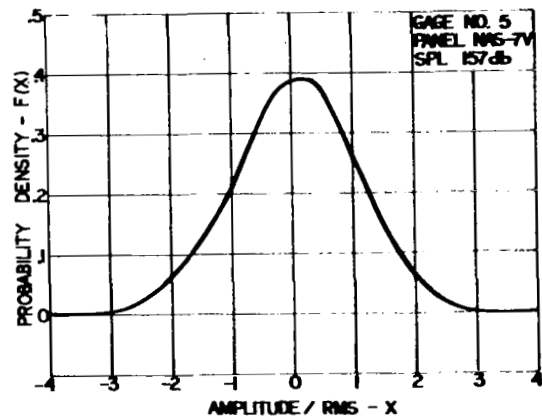
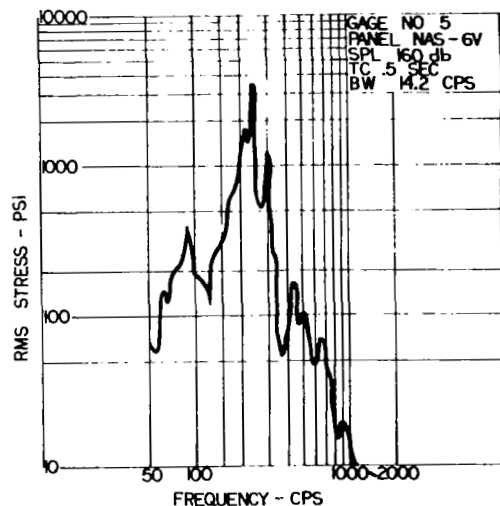
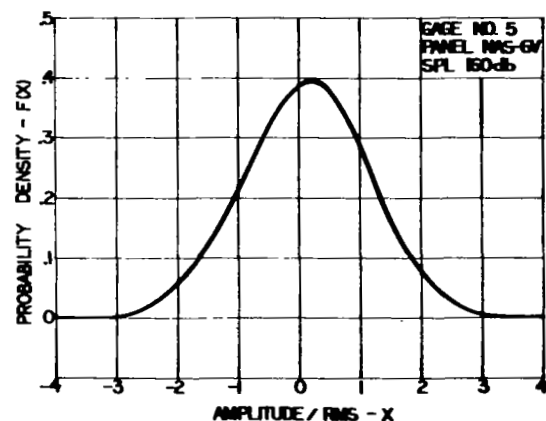
FIG.11 TYPICAL RMS STRESS RESPONSE
 AS A FUNCTION OF FREQUENCY AND
 PROBABILITY DENSITY ANALYSIS FOR V-E
 PANEL AT THE 3 SPL

In figure 11, the amplitude of maximum stress occurs at 235 cps with another relatively strong component at the 300 cps mode. At 157 db and 160 db, a modal response was detected at approximately 270 cps. The amplitude of this stress was equal to or slightly less than at 160 cps. This point, however, was not inserted into Table II. The probability density plot, figure 11, of the unfiltered strain gage signal bears a close resemblance to a normal distribution. This

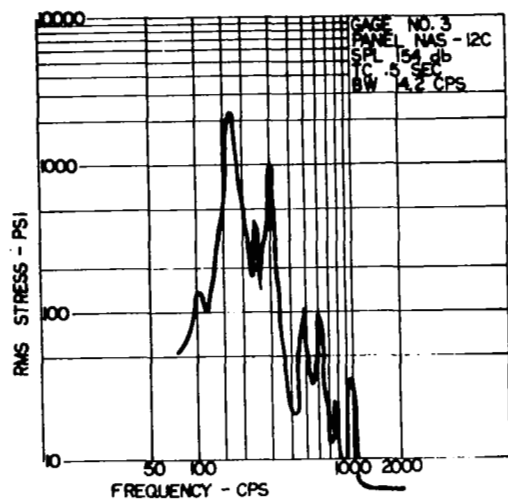
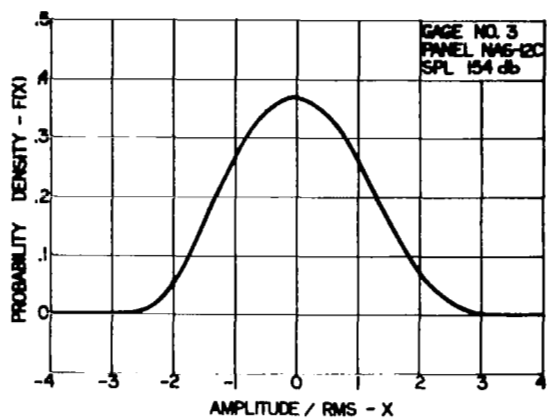
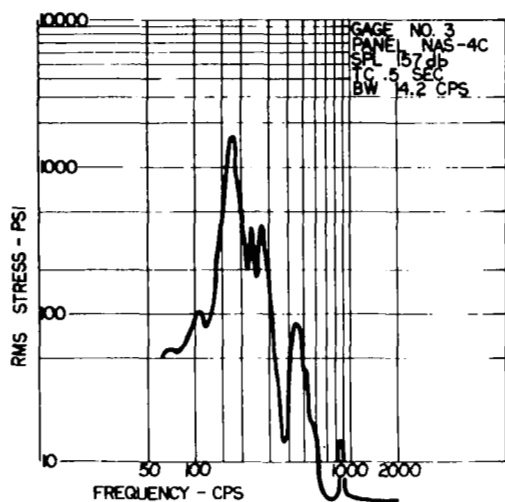
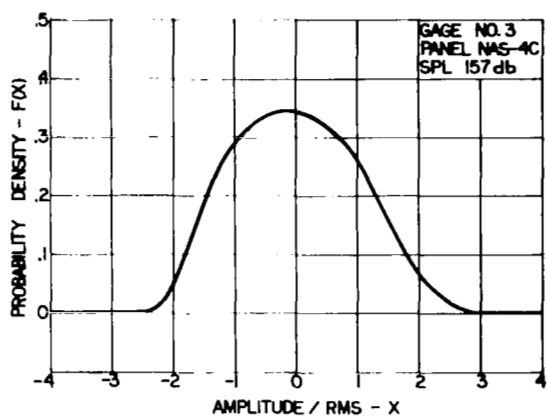
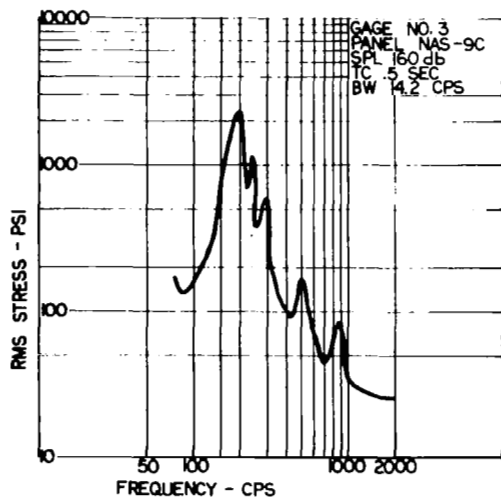
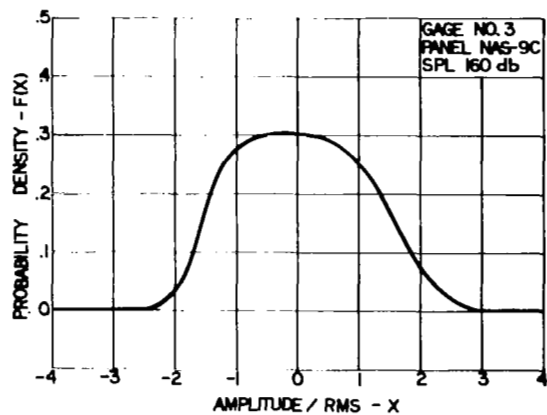
FIG. 12 TYPICAL RMS STRESS RESPONSE
 AS A FUNCTION OF FREQUENCY AND
 PROBABILITY DENSITY ANALYSIS FOR V-E
 PANEL AT THE 3 SPL

The data in figure 12 are a good representation of the stress-frequency and probability density behavior in the center bay area. The center bay is primarily being driven at its fundamental mode (160 - 165 cps) with the higher modes being less responsive to the acoustic input.

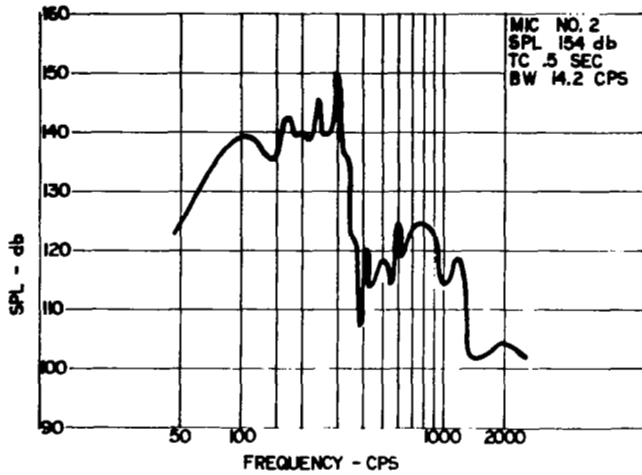
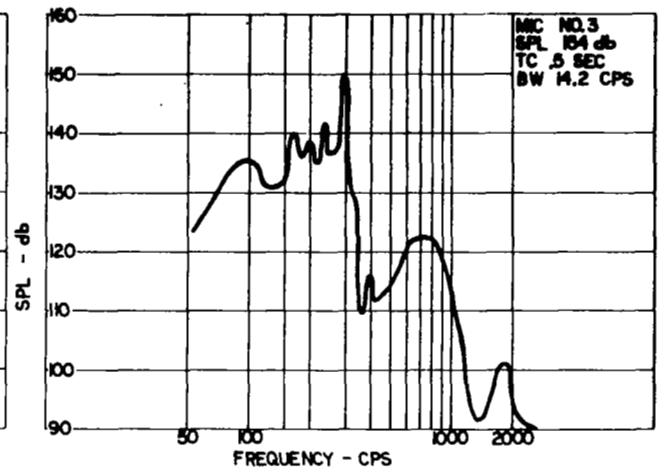
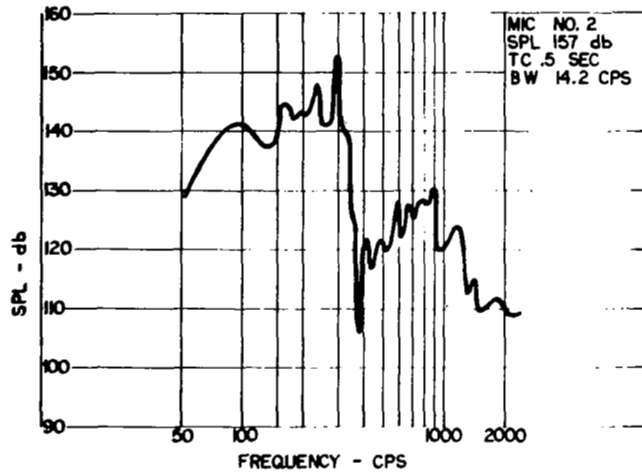
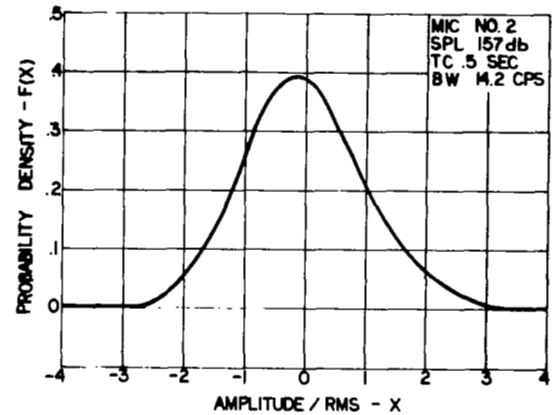
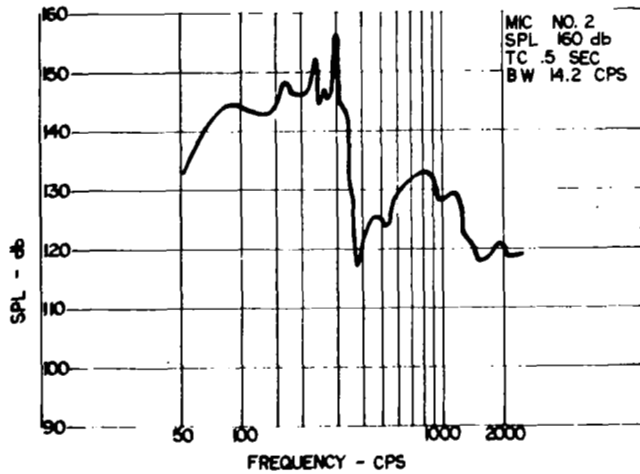
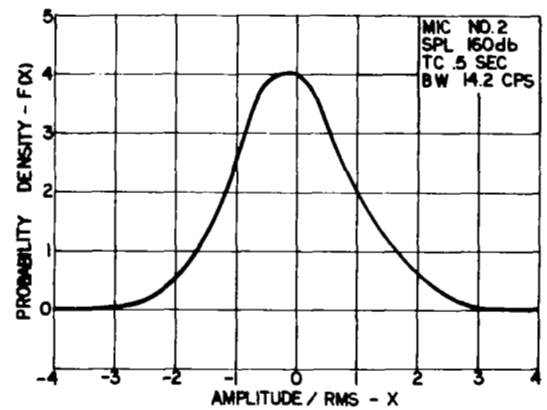
FIG. 13 NARROW BAND AND PROBABILITY DENSITY ANALYSIS OF THE NOISE SOURCE (BROAD BAND SIREN)

A harmonic analysis using a 14.2 cps effective bandwidth filter was conducted to determine the frequency content of the Broad-Band Siren at the three test levels of 154 db, 157 db, and 160 db. The data are reported in figure 13 at microphone locations 2 and 3. Microphone 3 was positioned at the center of the panel and microphone 2 near the center of bay area #3. The narrow-band analysis of these data shows that the noise source drops-off very drastically at 295 cps until it reaches a valley at 385 cps and then it gradually rises. This drop-off of the broad-band siren response in this region does not permit panel modes above approximately 335 cps to be excited strongly. However, from a preliminary modal analysis of the panel it is seen that only one of the four predominate modes is affected, the fourth mode. Within the region of the first three panel modes (160 - 300 cps) the amplitude of the noise source is maintained within a 5 db envelope, with the exception of two frequency points at 235 cps and 295 cps. The peak-to-valley ratio at 235 cps is approximately 10 db and at 295 cps as much as 14 db.

A probability density analysis of microphone 2 is also presented in figure 13 for an overall sound pressure level of 157 db and 160 db. This analysis typifies the results from all of the microphones used to monitor the noise. An octave band analysis is given in figure 14. Microphone analysis was conducted with the panels installed and with a 1/4 inch thick aluminum plate that was heavily damped with lead damping tape to determine the effects of panel radiation. No changes in frequency composition or amplitude were noted.

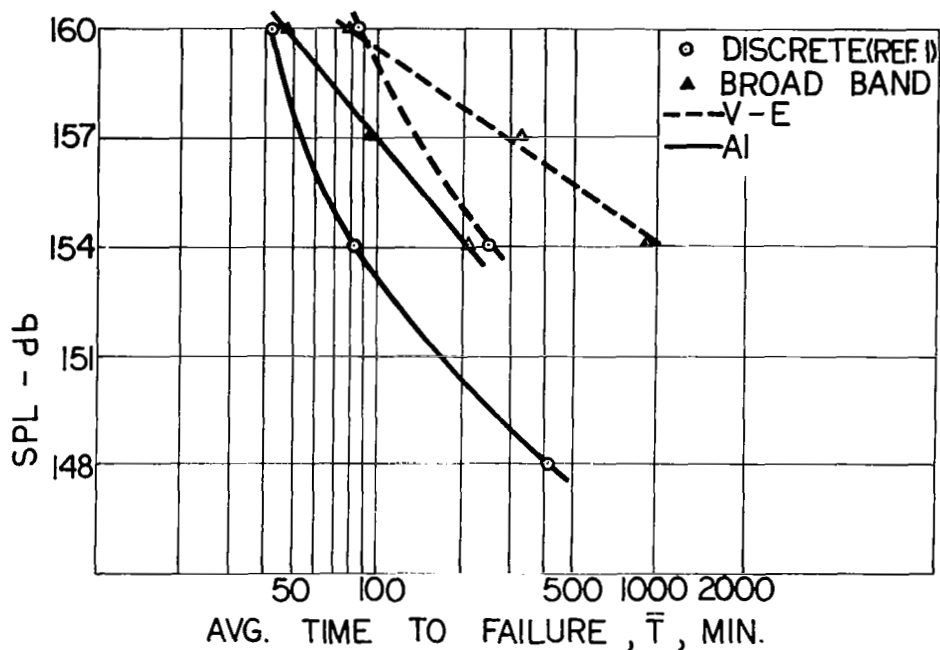
FIG. 15 COMPARISON OF PANEL FATIGUE LIFE AT DISCRETE AND BROAD BAND TESTING

Sonic fatigue data were obtained on a limited set of aluminum viscoelastic and aluminum control panels at discrete frequency, as reported in reference 1, and with random (broad-band) acoustic excitation. The comparison of these results is made in figure 15. Discrete frequency testing was conducted at sound pressure levels of 148 db, 154 db, and 160 db; broad-band testing was performed at an overall SPL of 154 db, 157 db and 160 db.

In figure 15, the average time-to-failure is plotted as a function of the overall sound pressure level. Comparing the data from the two types of excitation, it is shown that good correlation in fatigue time exists at a sound pressure level of 160 db. However, as the SPL is reduced, the time-to-failure relation has a tendency to diverge, with the fatigue time for discrete loading being shorter at a given sound pressure level. This scatter in fatigue life was also present between each similar type of sample tested at a given SPL, especially in the viscoelastic panels.
